Amelia Walk Community Development District

2024 Annual Engineers Report

June 28, 2024

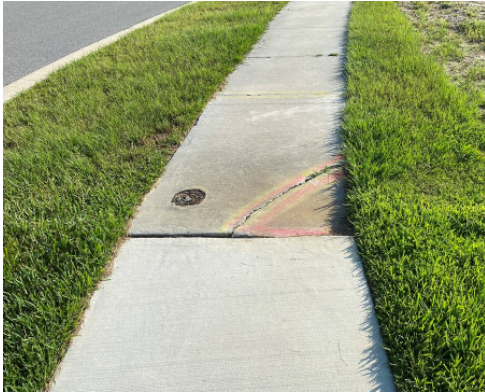
Damaged sidewalk in front of 85475 Fall River Pkwy

- Routine sidewalk inspections should be scheduled and uneven sidewalks with lips exceeding ¼” should be addressed to meet ADA standards
- Two damaged sidewalks were found and should be repoured

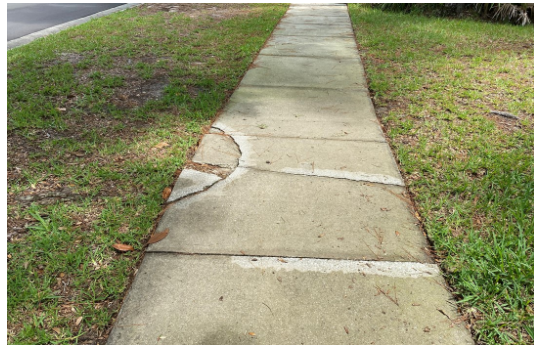
Damaged Sidewalk near roundabout

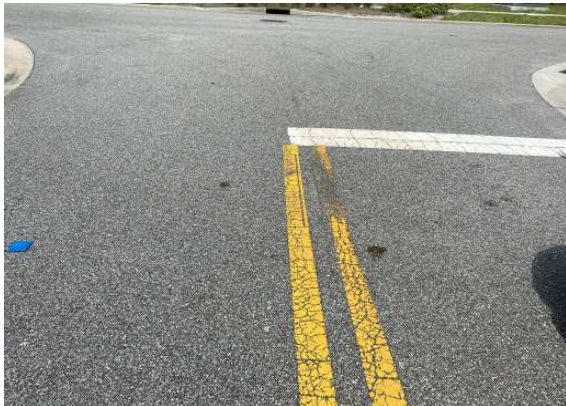
Faded striping in phase 2

- Phase 2 striping is fading and should be restriped in the next two years
- Gutter in front of one driveway is chipped and should be repaired
- There is one shallow depression in front of an inlet, and another inlet has a small pothole near it. These locations should be monitored

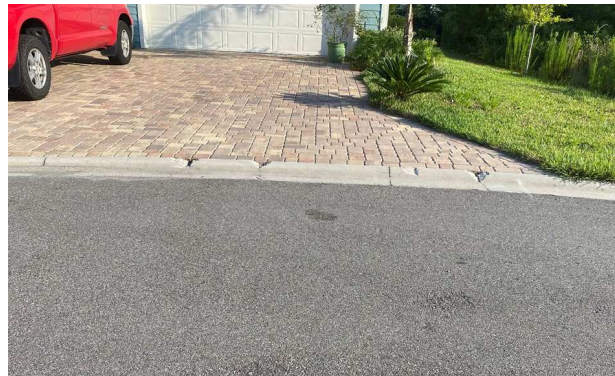
Gutter is chipped in front of 85265 Sagamore Ct

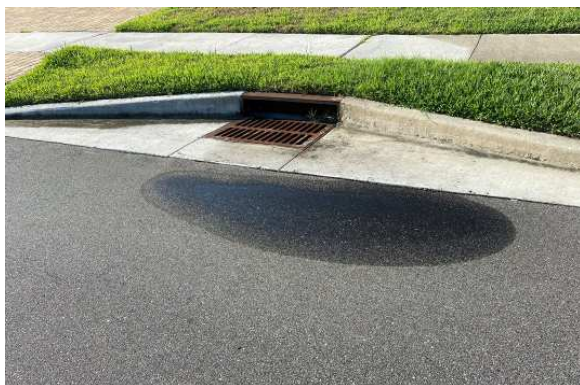
Shallow depression in front of inlet on Fall River Pkwy

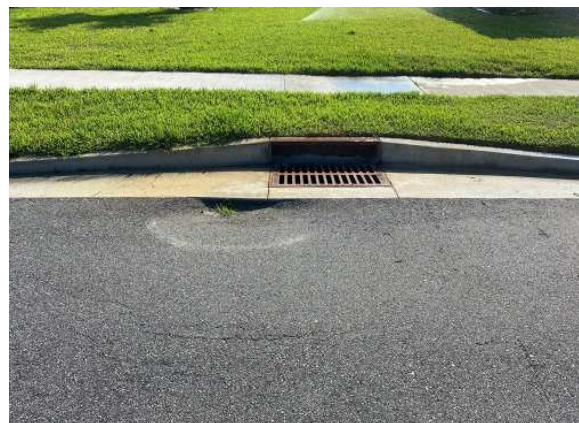
Small pothole near inlet on Fall River Pkwy

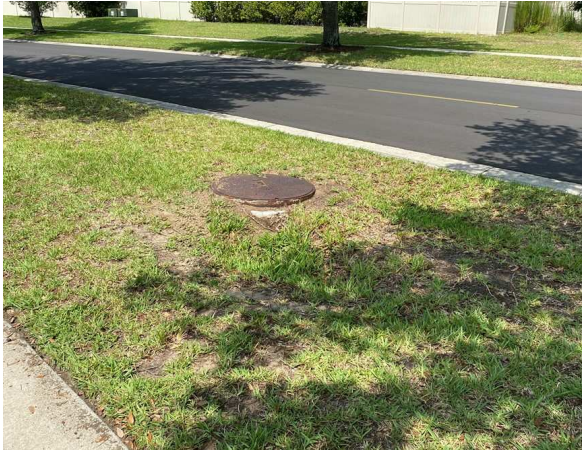
Small hole near storm manhole off Majestic Walk Blvd

- A storm manhole near the Spruce Run Drive & Majestic Walk Blvd intersection has a small hole next to it. This should be filled and monitored thereafter

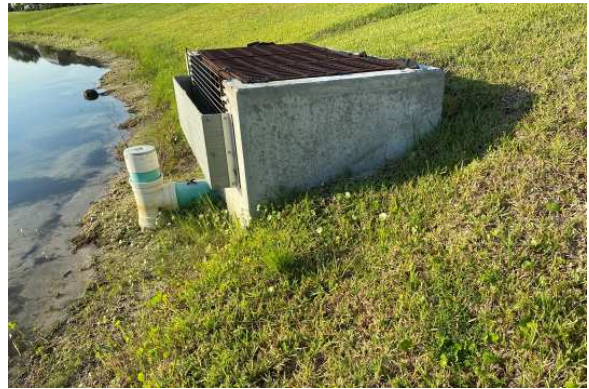
Inlet protection installed on phase 5b pond...also clean out under bottom of orifice pipe

- Two control structures in phase 5B have silt protection installed on top. These should be removed unless active construction is nearby
- There are two pond locations with minor erosion forming on the slope. These areas should be filled, compacted and sodded

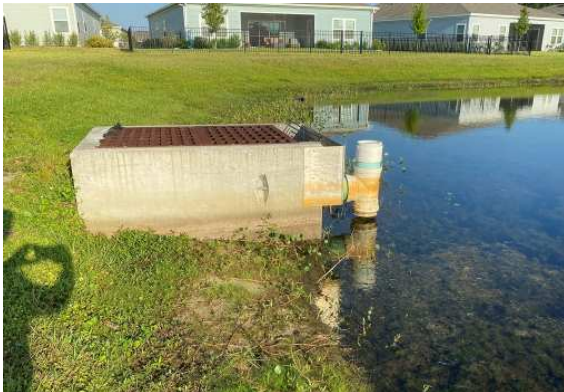
Inlet protection installed on phase 5b pond

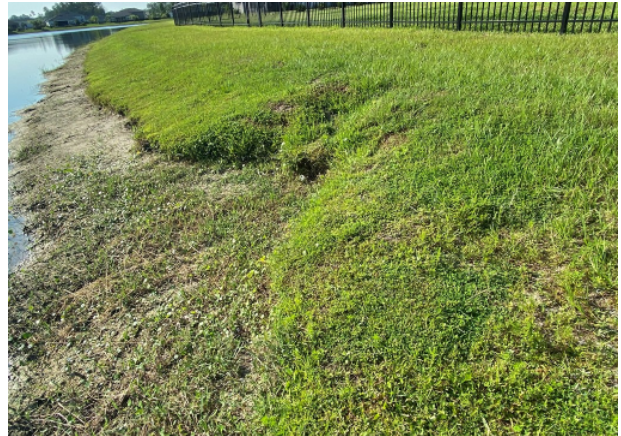
Erosion on phase 4A pond slope

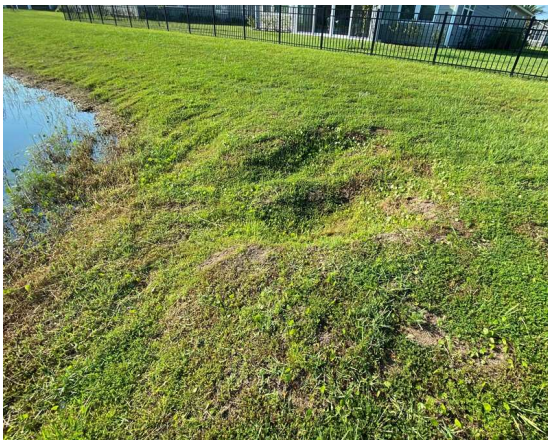
Erosion on phase 4B pond slope

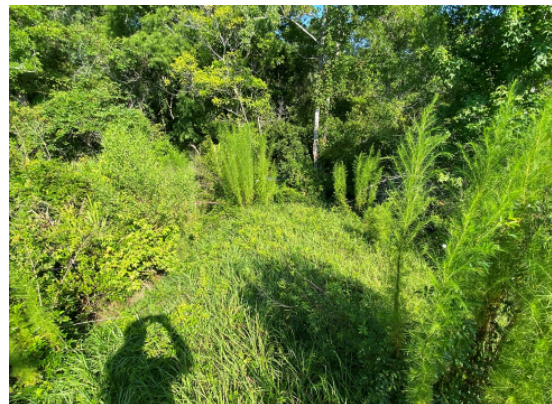
Fallen Leaf Drive pond outflow (overgrown)

- Five pond outflow structures have poor access due to overgrowth. These areas should be cleared for future maintenance access

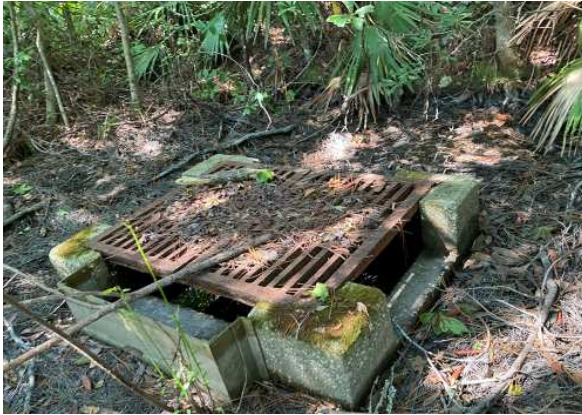
Cherry Creek Drive pond outflow (access is overgrown)

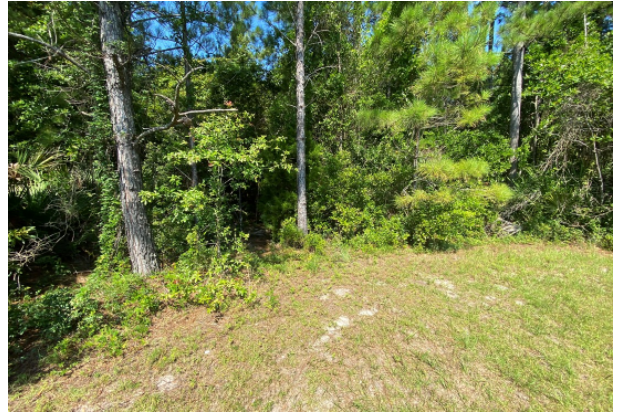
Majestic Walk Blvd pond outflow (access is overgrown)

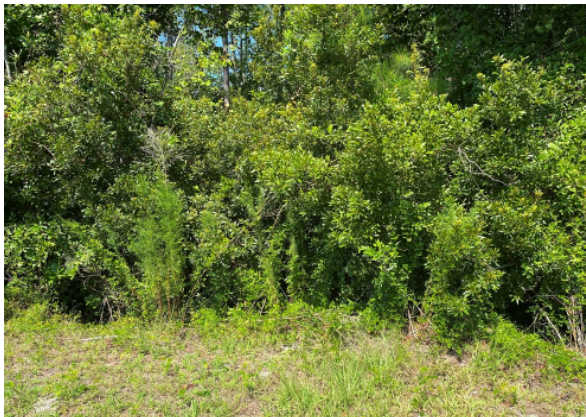
Majestic Walk Blvd pond outflow (access is overgrown)

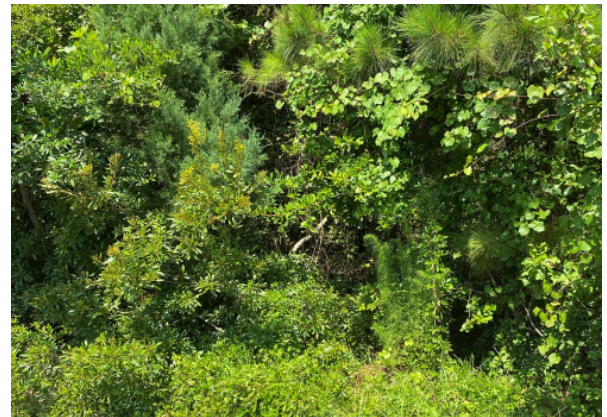
Majestic Walk Blvd pond outflow (access is overgrown)
