# Pond Assessment Report

| Field | Details |
|---|---|
| Account Name | Amelia Walk CDD |
| Report Date | 3 Sept 2026 |

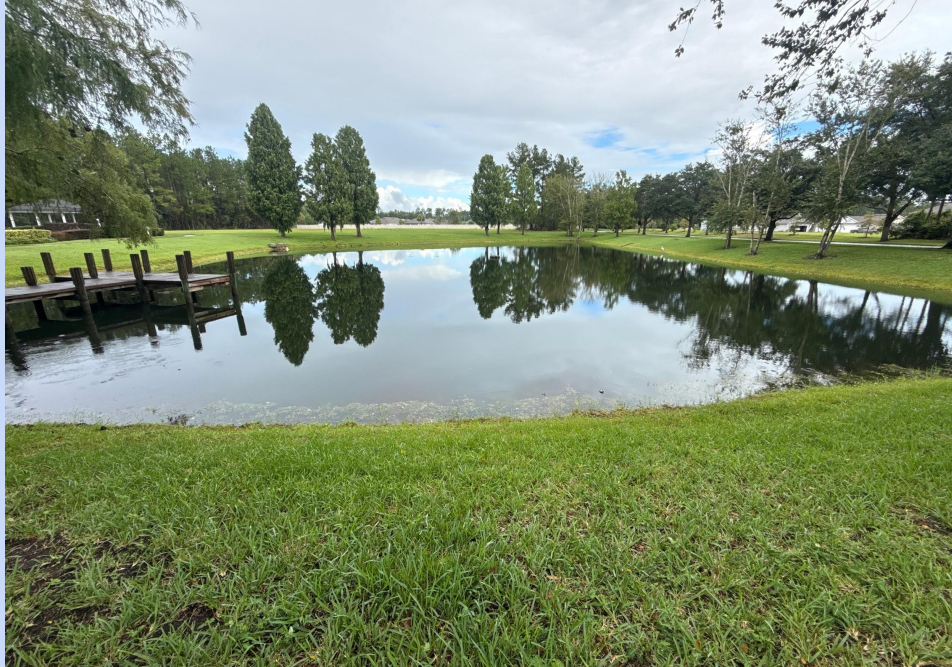
Pond Name/ Number: 2

Very minor algae growth along the perimeter. No signs of submerged vegetation or shoreline growth. No trash seen either. The fountain was down and our team was alerted.

The algae is growing around the perimeter and areas where I saw some grass clippings in the pond. Grass clippings are high in nutrients and algae love to feast and grow on it. I would recommend getting some native littoral plants planted around the perimeter. They do three things for you: they create a buffer zone for grass clippings and nutrient rich runoff from entering the pond, they create habitat for small fish to hide in, and they improve the aesthetics of the pond. We do offer this service if you are interested.

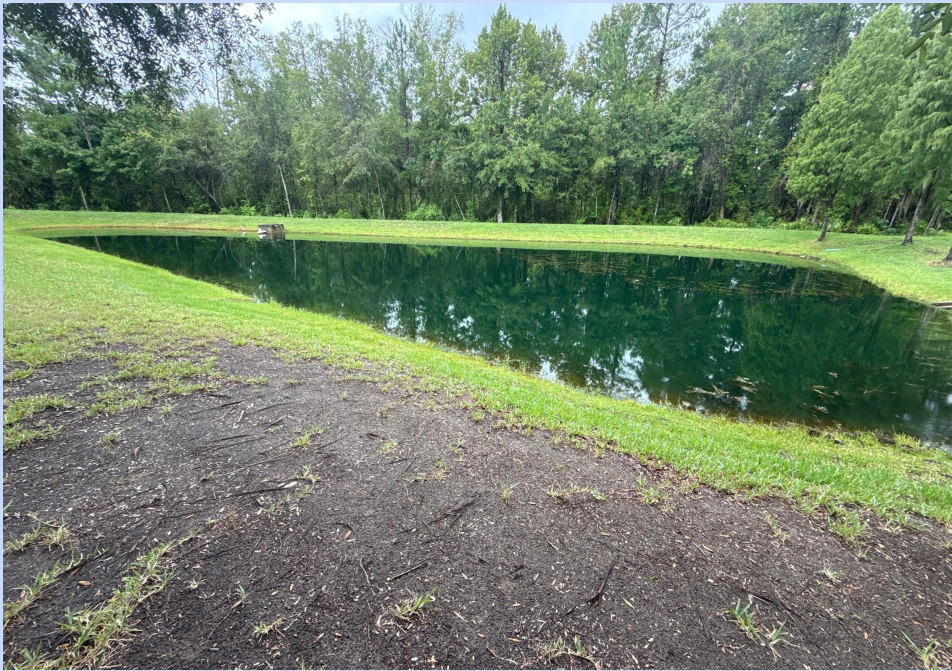
## Pond Name/ Number: 3

Minimal algae growth present along the shoreline. No shoreline vegetation or submerged aquatic vegetation observed. No trash found either.

As with pond 2 this pond is small and is also dealing with some algae stemming from grass clippings. I would also recommend native littorals be planted here as well.

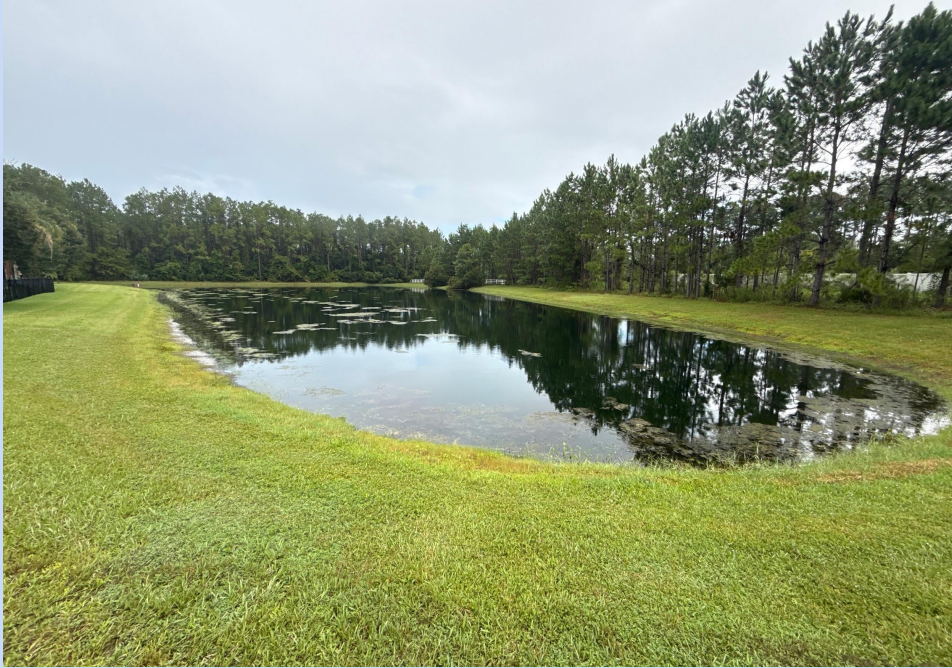
## Pond Name/ Number: 4

This pond has some submerged vegetation growing in the pond though it has surfaced and is causing an algae bloom in spots. No shoreline grasses found around the perimeter. No trash found at this time.

We will get this vegetation knocked down and in the future there may be more recommendations for this pond if growth comes back quick. As of right now I do not want to recommend anything further.

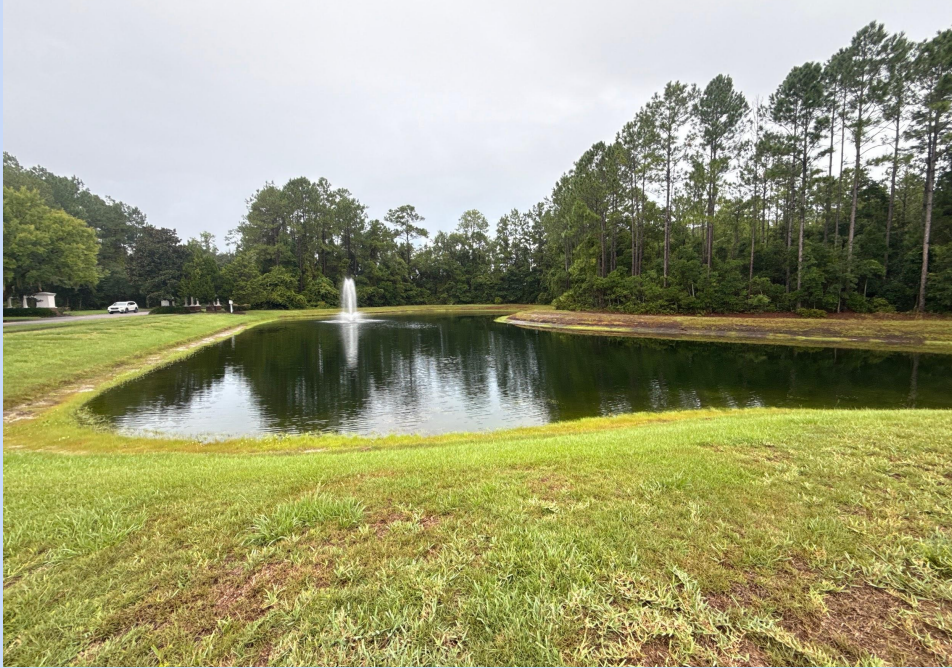
## Pond Name/ Number: 5

Minimal shoreline vegetation growing around the perimeter of the pond. No algae detected. Submerged slender spikerush is present but not surfacing. No trash was observed along the banks. Water levels are low on this pond and expose the shoreline vegetation.

No recommendations at this time.

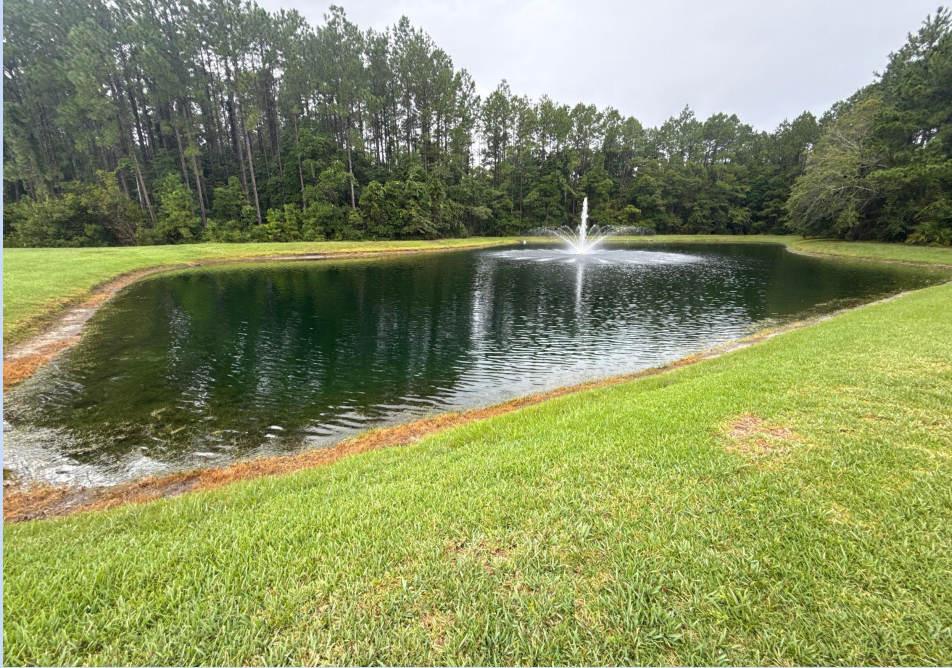
## Pond Name/ Number: 6

On pond 6 I see signs of previously treated vegetation along the perimeter. No signs of any algae or trash. There is some submerged vegetation but it is not topping out and causing issues.

We will continue to monitor the submerged vegetation and ensure that if it ever causes problems we will treat it accordingly. No recommendations at this time.

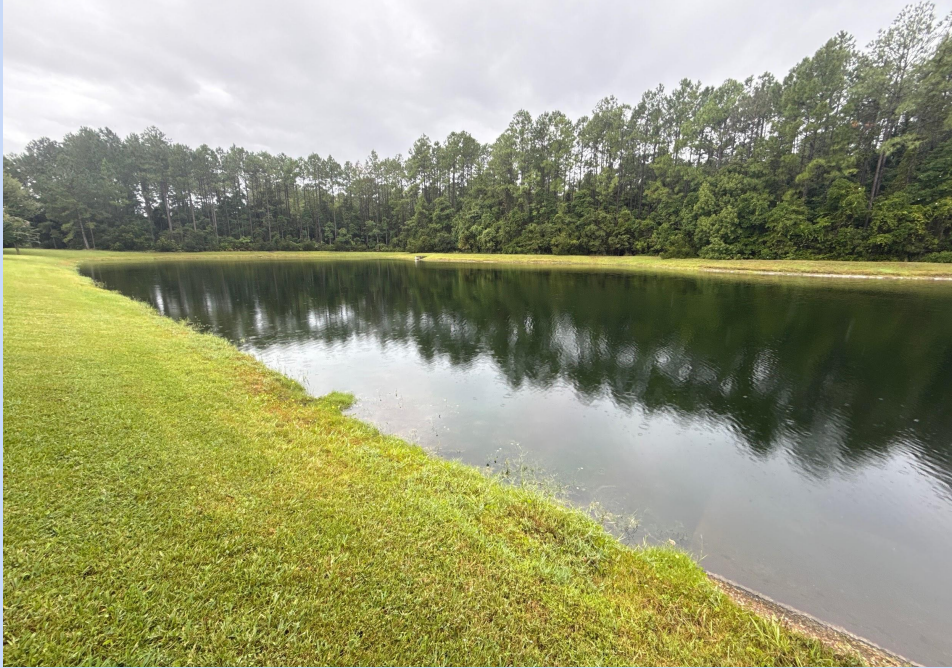
**Pond Name/ Number: 7**

Very minor growth of invasive shoreline torpedo grass. No algae or submerged vegetation detected. No trash found either.

No recommendations for this pond as it is very well maintained and no underlying issues are present.

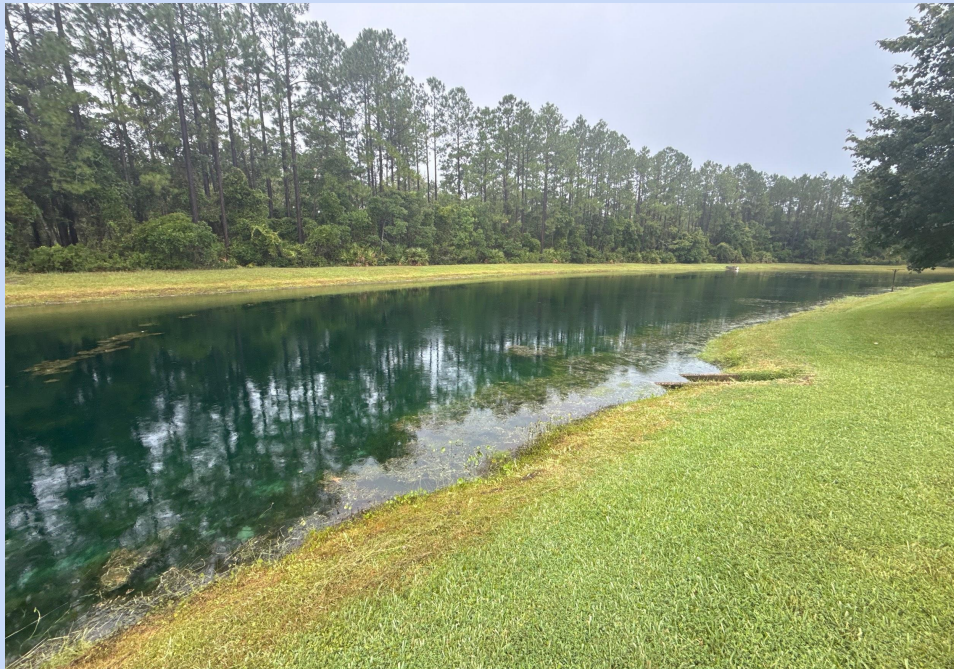
## Pond Name/ Number: 8

Very minimal amounts of shoreline grasses spotted around the perimeter of the pond. There is some submerged vegetation starting to surface as well. The surfaced vegetation is causing some algae in the pond this time. Mainly this is observed around the shoreline and indicates that nutrient runoff is playing a part in the growth.

Since we are trying to limit the inflow of nutrients into the pond I would recommend again the idea of planting this one with native littoral plants like pickerelweed and arrowheads.

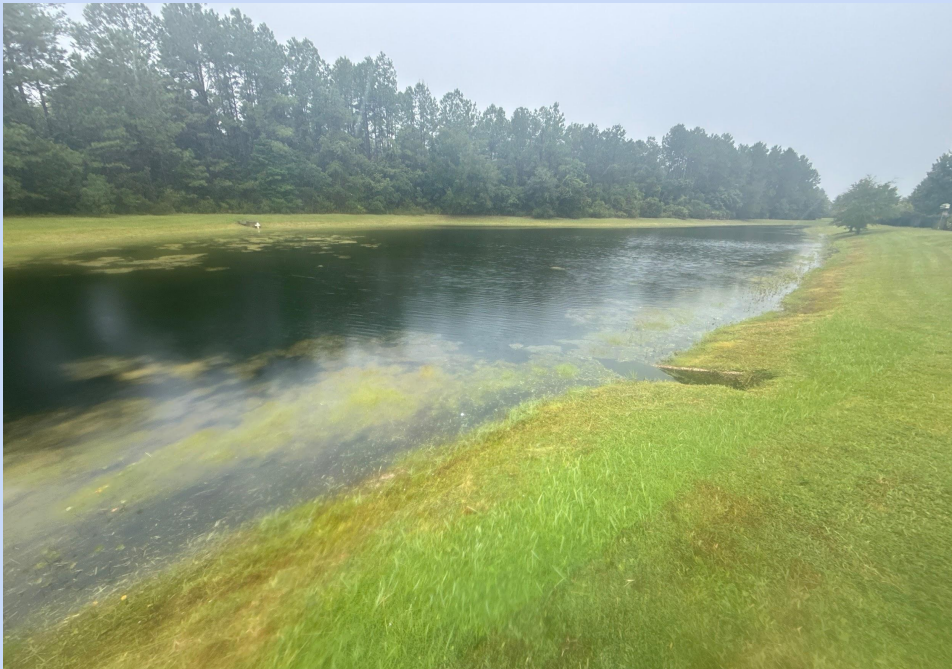
## Pond Name/ Number: 9

Minor algae around the perimeter of the pond growing along minor shoreline grasses. The pond also has some slender spikerush that is surfacing as well. No trash observed in the pond.

We will get this vegetation knocked down and in the future there may be more recommendations for this pond if growth comes back quick. As of right now I do not want to recommend anything further.

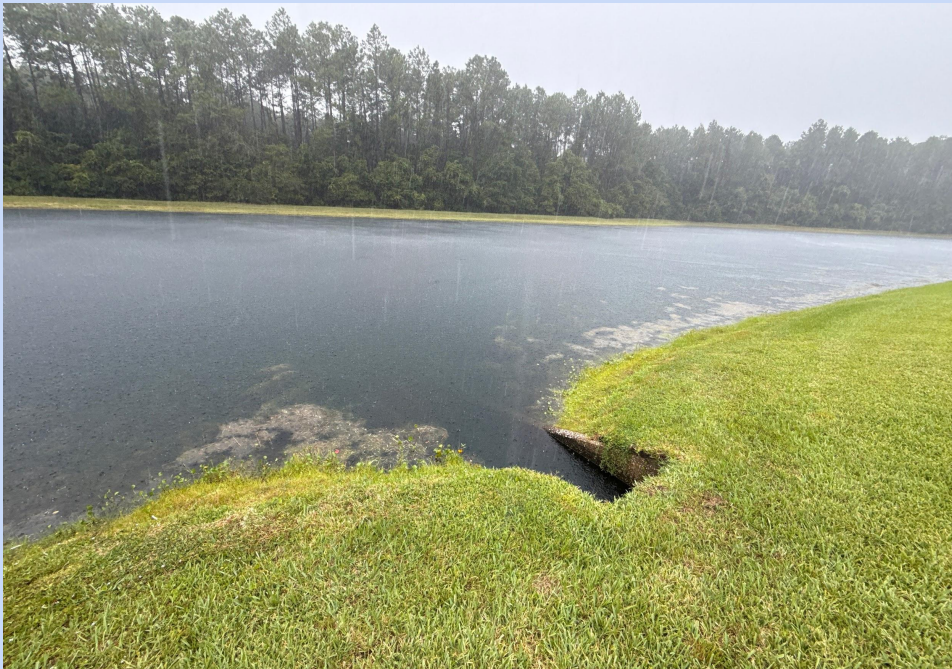
## Pond Name/ Number: 10

Very minor algae seen in the pond along the perimeter. No signs of any invasive shoreline vegetation at this time. No trash observed. Submerged vegetation was not found during this check.

Since we are trying to limit the inflow of nutrients into the pond I would also recommend the idea of planting this one with native littoral plants.

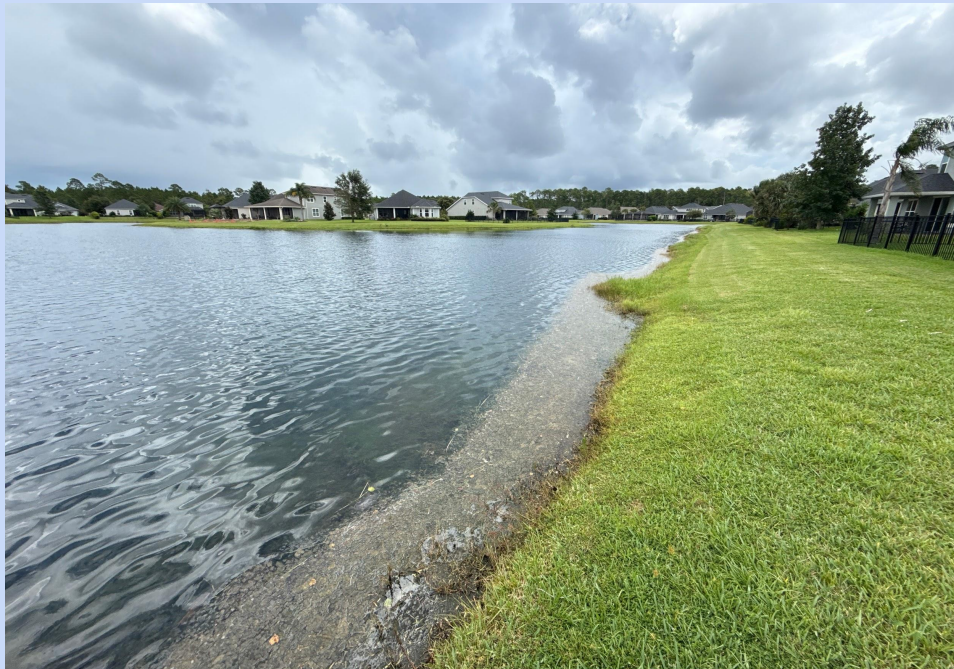
## Pond Name/ Number: 11

On pond 11 I noted the large patches of invasive torpedo grass that is growing out into the pond. The vegetation is also present below the historic edge of the pond. Algae is present growing in and around the perimeter grasses. No submerged vegetation observed. The algae is also seen growing from the depths of the pond.

For this pond we will get the grasses back under control by the use of an atv to shoot down the bank and get better control of the vegetation. Seeing the algae growing from the bottom of the pond gives me the thought that you have high nutrients concentrated in this pond. I would like to get a water quality test done to see where we sit currently and if a nutrient remediation treatment or possibly aeration is needed for this pond.

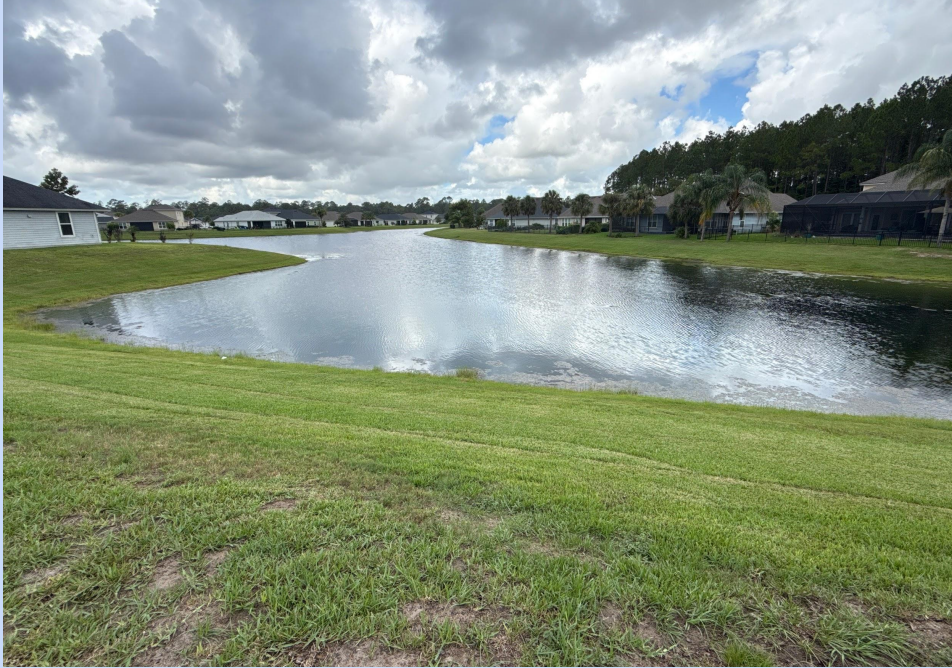
## Pond Name/ Number: 12

Very little shoreline vegetation observed this visit. The main issue that this pond is dealing with is a large ring of slender spikerush growth. Algae is present in spots as well. No trash was found in this pond.

I would like for us to get a handle on this growth in the pond first. From there if it returns fast I would possibly have more ideas. At this time I will hold off on any further recommendations.

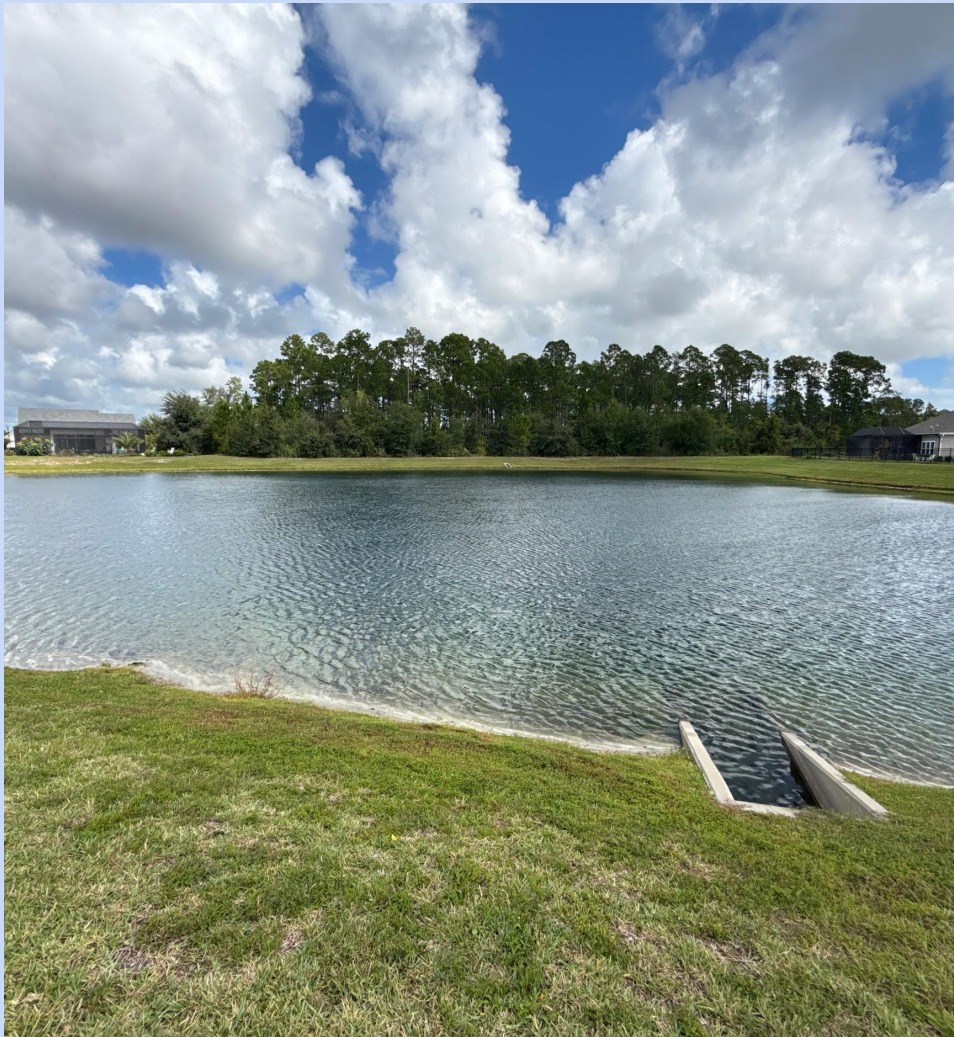
## Pond Name/ Number: 13

No signs of any invasive shoreline vegetation during my inspection. No algae was seen on the pond. Submerged vegetation was not present either. No trash found in or around the pond. The pond looks great overall.

No recommendations today for this pond.

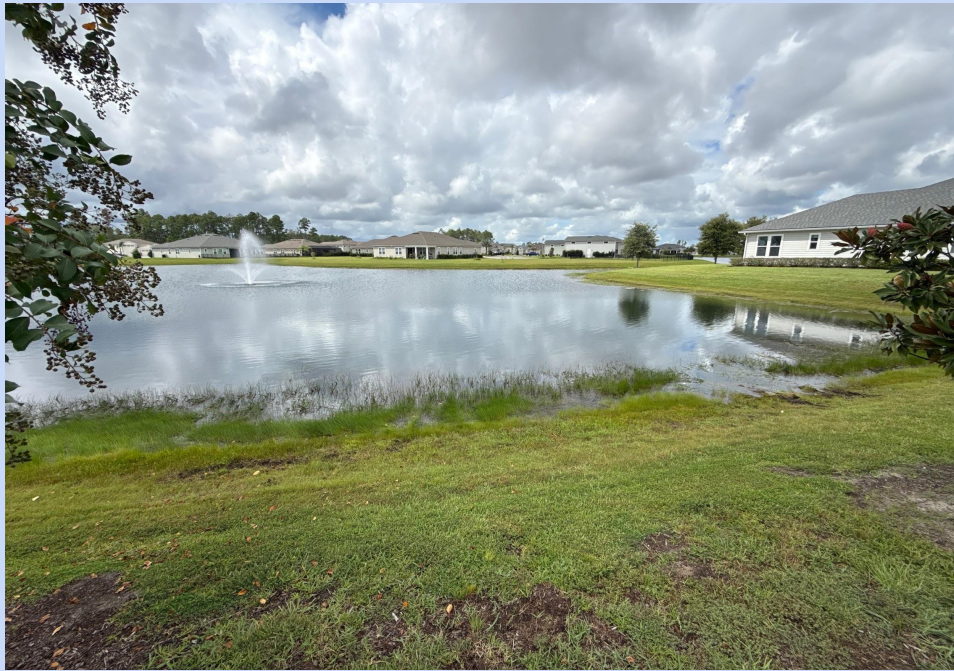
## Pond Name/ Number: 14

Large amounts of invasive Torpedo Grass were found around the perimeter. No algae was seen. Submerged vegetation was not present during this inspection. Trash was also not a thing on this pond.

This is another pond where the main issue stems from the shoreline and often indicates some nutrient rich runoff heading into the pond. Native littorals uptaking and growing off of these nutrients would look much better compared to the growth seen currently.

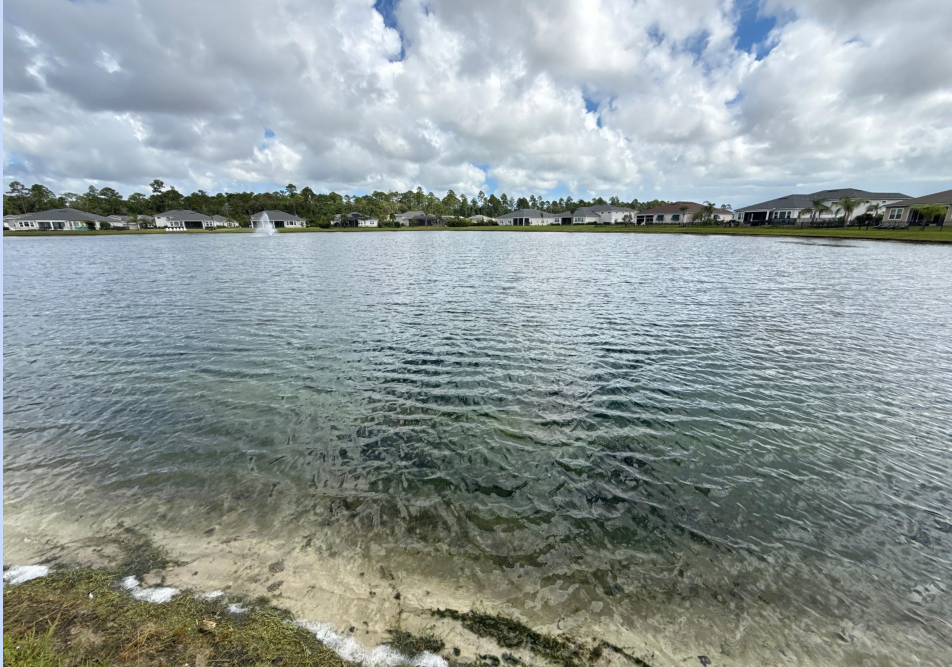
## Pond Name/ Number: 15

No algae growth observed. Submerged Slender Spikerush is present in the pond but has yet to surface. This is a native plant so we control it as needed or when it tops out. No trash found in or around the pond.

No recommendations at this time. We will monitor the growth and determine if any further steps need to be taken.

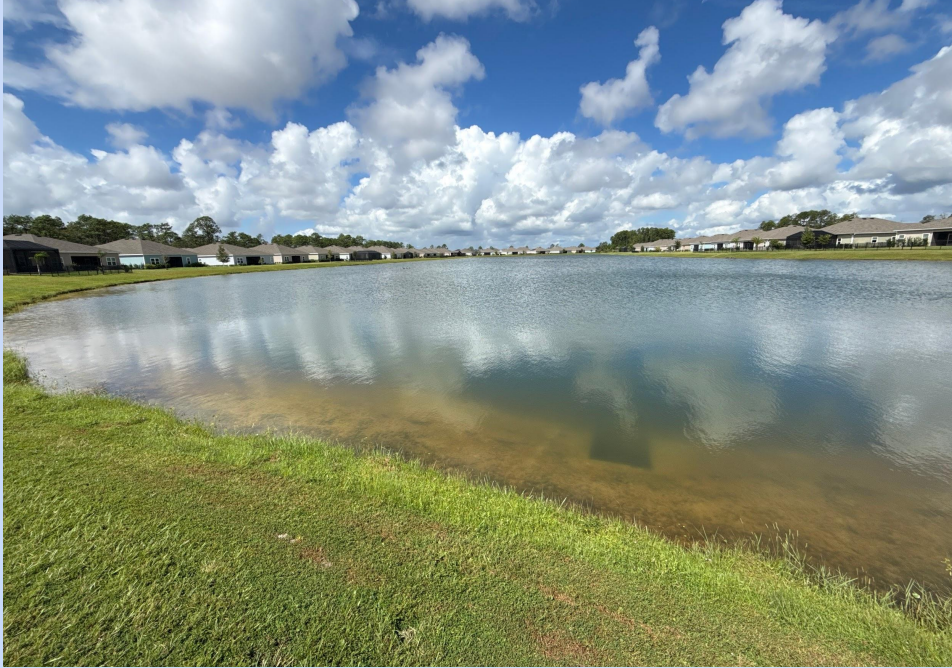
## Pond Name/ Number: 16

No algae seen. No trash found. No growth of shoreline vegetation seen. Also no submerged vegetation either.

This pond looks great overall! If anything to help native bees and fish I would recommend we plant the shoreline with native littoral vegetation.

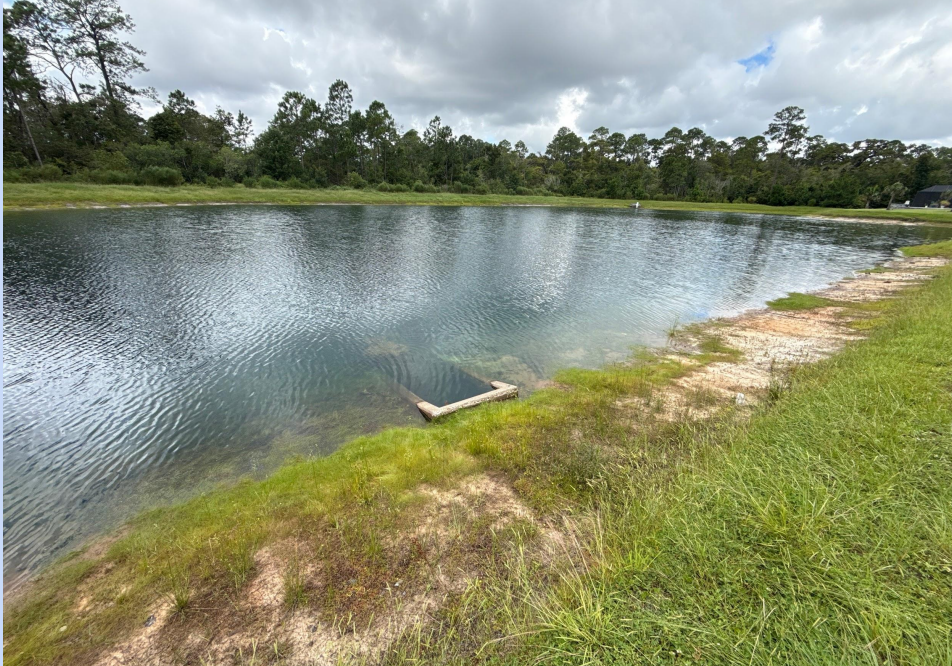
Pond Name/ Number: 17

Minimal shoreline vegetation growing around the perimeter of the pond. No algae detected. Submerged slender spikerush is present but not surfacing. No trash was observed along the banks. Water levels are low on this pond and expose the shoreline vegetation.

No recommendations at this time.
